GEOTECHNICAL REPORT

Slope Stability Analysis York Downs Golf Club Redevelopment Markham, Ontario

Report Number: 1413472 (8000)

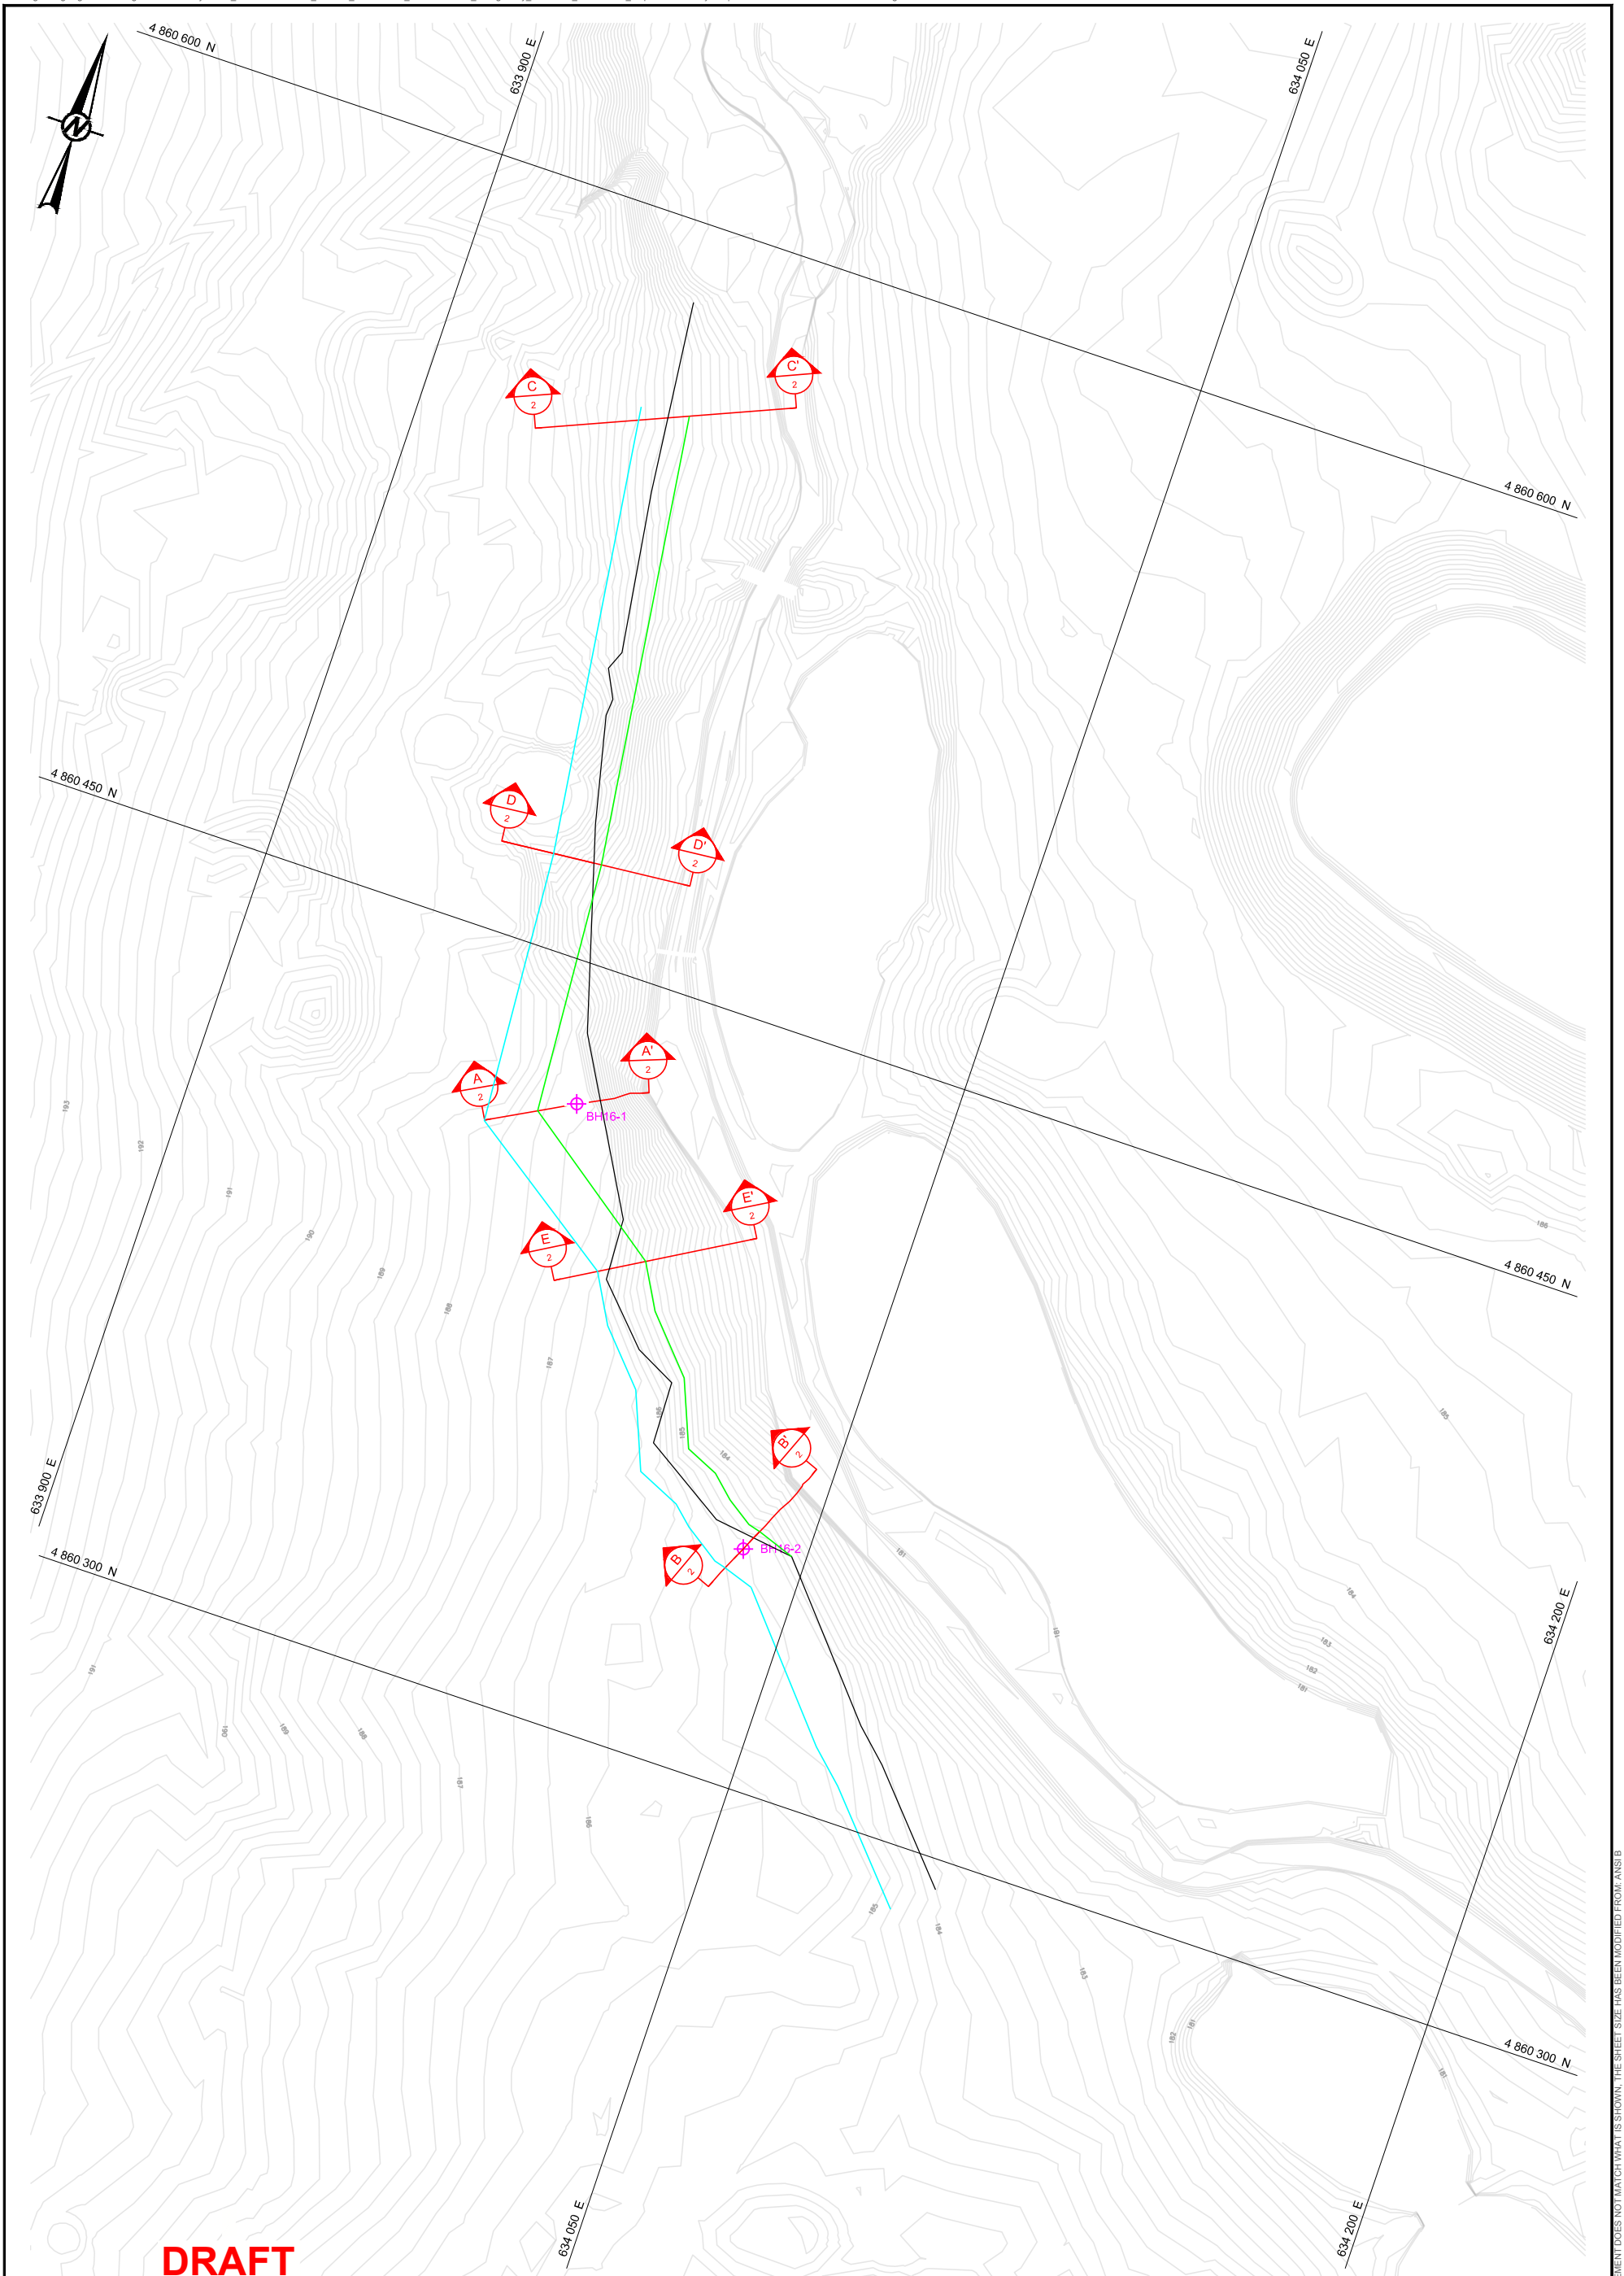
PROJECT NO. 1413472	PHASE NO. 8000	REV. A	FIGURE 1
------------------------	-------------------	-----------	-------------

Refer to Figure 2 for the setback limit within the study area. As noted above the setback provided in the above table and on Figure 2 is based on the Toe erosion allowance, stable slope configuration, and TRCA access allowance. Based on our analysis, on four of the five sections (B-B' to E-E') the Top of Stable Slope was determined to be inside (closer to the creek) of the Staked Top of Slope Line. Within the study area, the Natural Hazard Setback line shown on Figure 2 reflects the Top of Stable Slope Line plus the 10m TRCA Access Allowance.

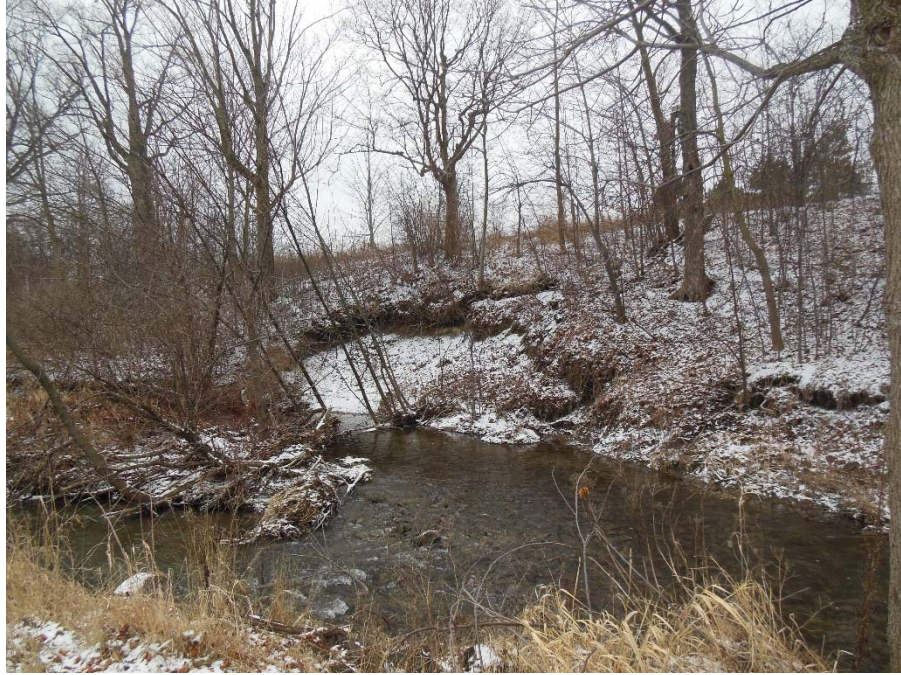
Site Photographs - Figure D1

- Localized areas of shallow sloughing of the near-surface slope materials were noted along the slope face adjacent to Borehole 16-1. The shallow sloughing appears to have been the result of bank erosion at the toe of the slope due to undercutting of the bank by the creek.

Local sloughing of slope adjacent to Borehole 16-1 looking to the south

The surficial erosions and local failures on the slope surface should be re-vegetated.

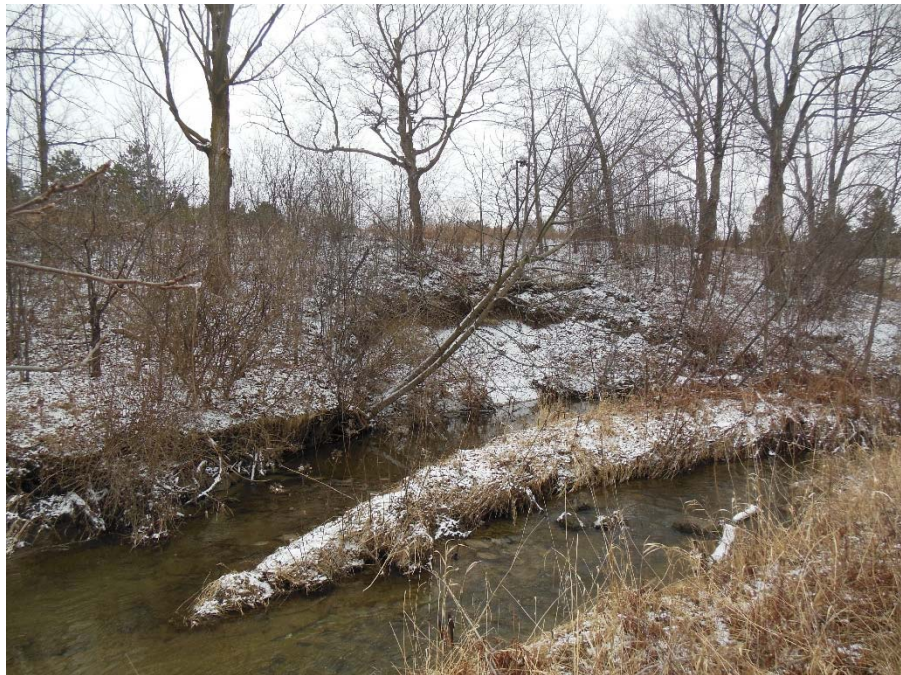
Local sloughing of slope adjacent to Borehole 16-1 looking to the north

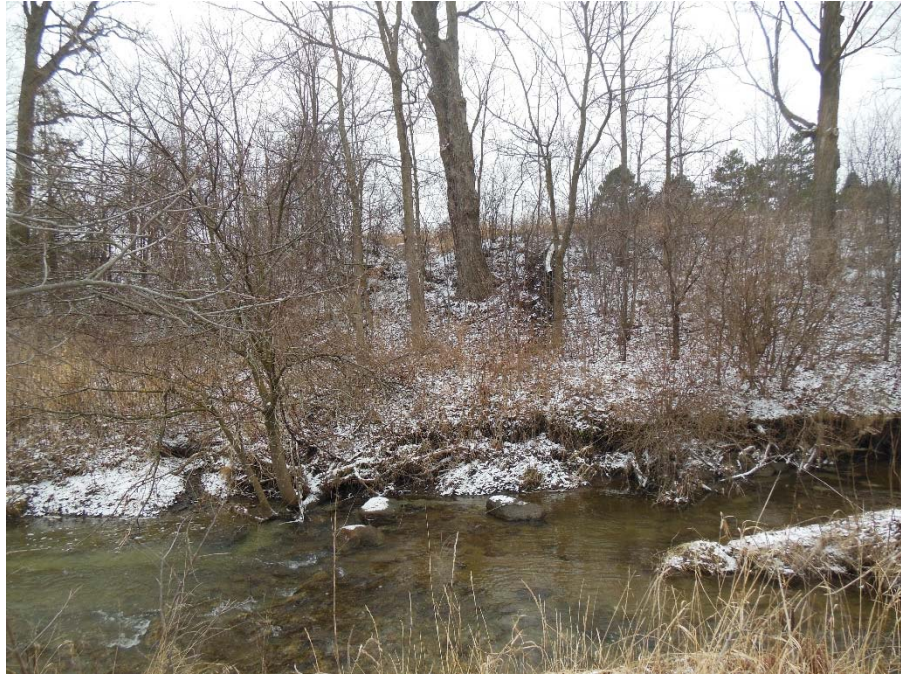
Site Photographs - Figure D2

In summary, toe erosion in the form of undercutting was observed on the west side of Bruce Creek where the creek channel is present at the toe of the slope. It is likely that the erosion of the toe of the slope has led to local slope failures at the toe and on the face of the slope. Curved tree trunks were noted south of Borehole 16-2, which may indicate long-term surficial movement of the slope, which could be caused by the on-going erosion of the toe of the slope. In addition, a few small gullies have formed at the crest and down the face of the slope. However, no signs of deep-seated slope instability, such as tension cracks, were noted during the visual reconnaissance on the western bank of Bruce Creek within the study area. A selection of site photos taken during the visual slope field review are attached to this report as Appendix D.

Undercutting at toe of slope adjacent to Borehole 16-2

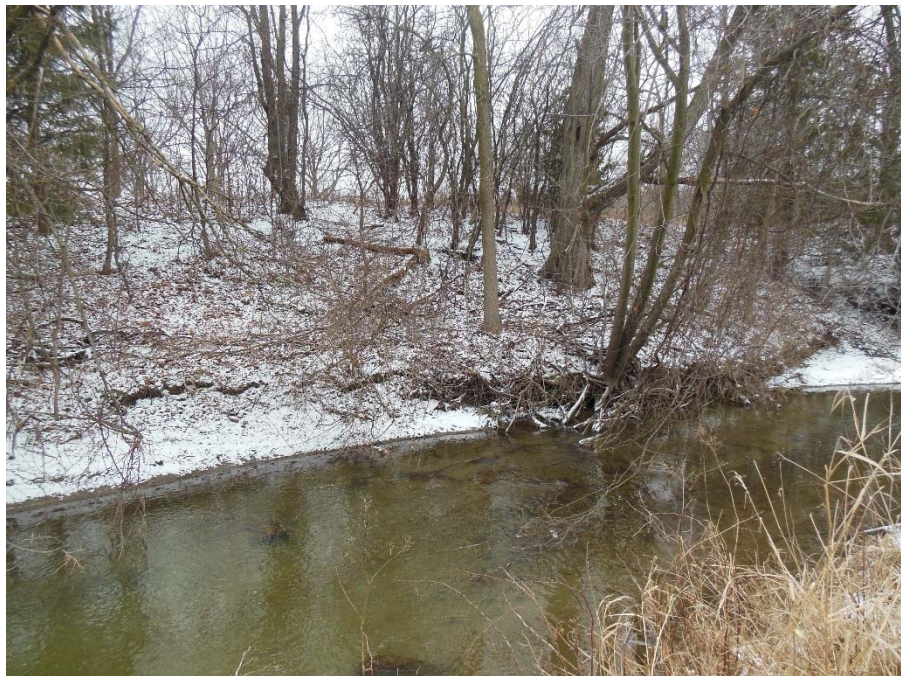
Undercutting at toe of slope leads to bank erosion adjacent to Borehole 16-2

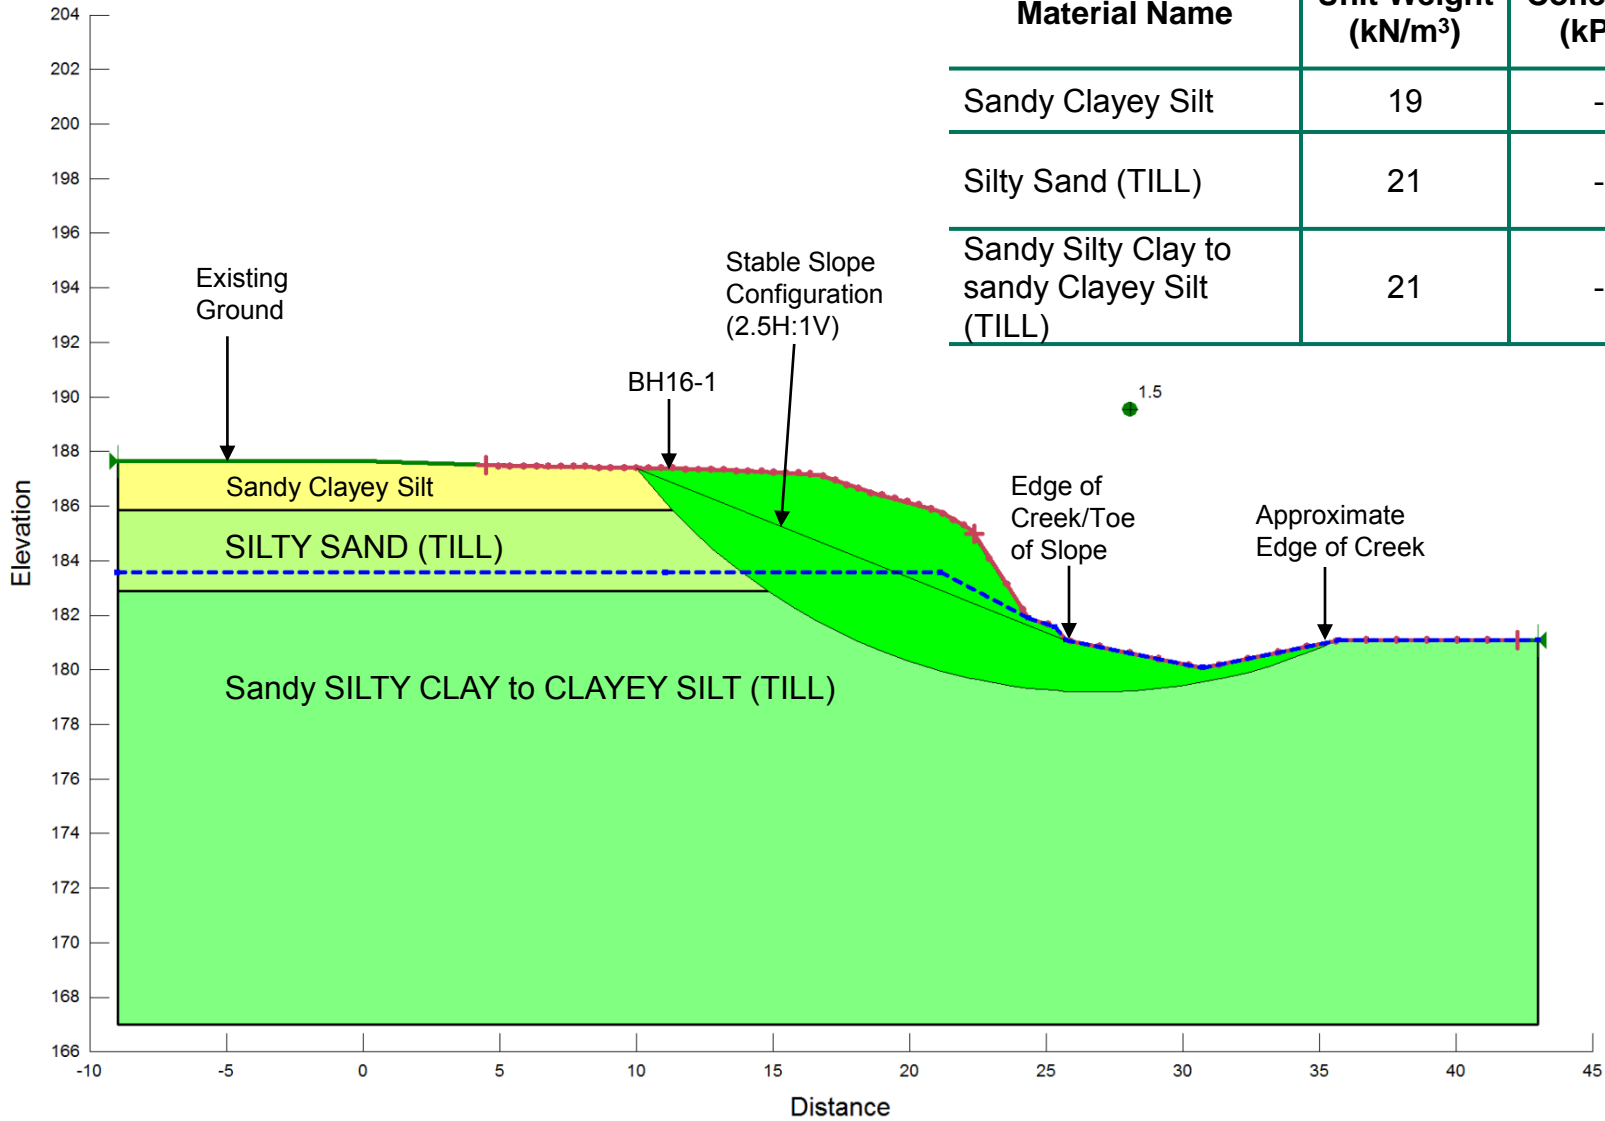
Figure E1

The results of the slope stability analysis conducted for the slope section near the location of Borehole 16-1, as shown on Figure E1, in Appendix E, indicate that the family of slip surfaces required to achieve a Factor of Safety of about 1.5 against global (i.e. deep-seated) slope instability requires a slope angle of approximately 2.5H:1V extending up from the toe of the slope. This corresponds to a stable slope allowance of approximately 15.0 m (based on a 6 m high slope).

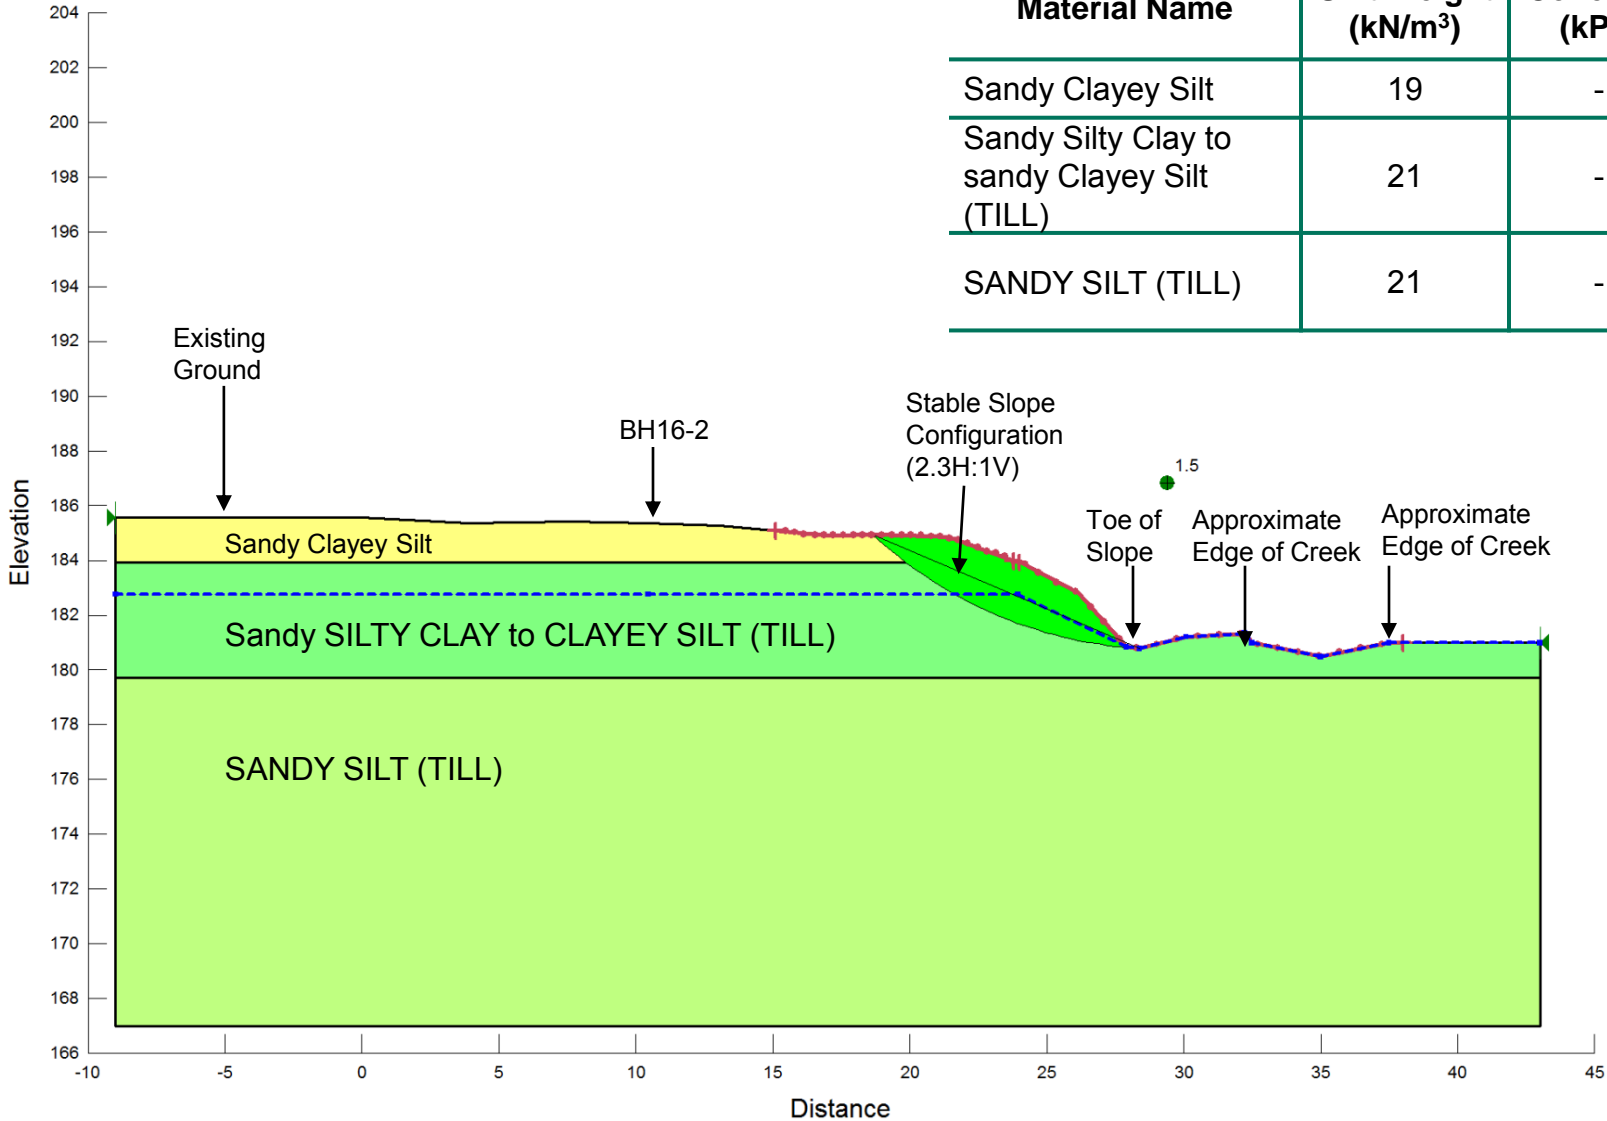
Figure E2

The results of the slope stability analysis for the slope section in the vicinity of Borehole 16-2, as shown on Figure E2, in Appendix E, indicate that the family of slip surfaces required to achieve a Factor of Safety of about 1.5 against global slope instability define a slope angle of approximately 2.3H:1V extending up from the toe of the slope. This corresponds to a stable slope allowance of approximately 9.2 m (based on a 4 m high slope).

**Slope Stability Analysis
Section B-B (Borehole 16-2)**
