GEOTECHNICAL REPORT

Slope Stability Analysis York Downs Golf Club Redevelopment Markham, Ontario

Report Number: 1413472 (8000)

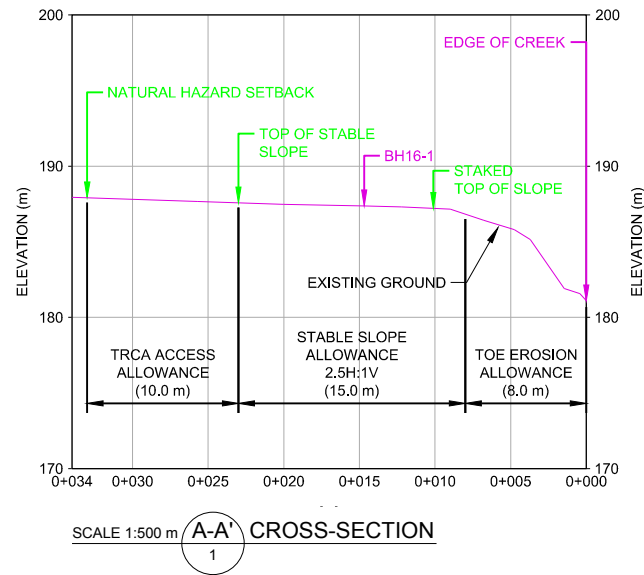
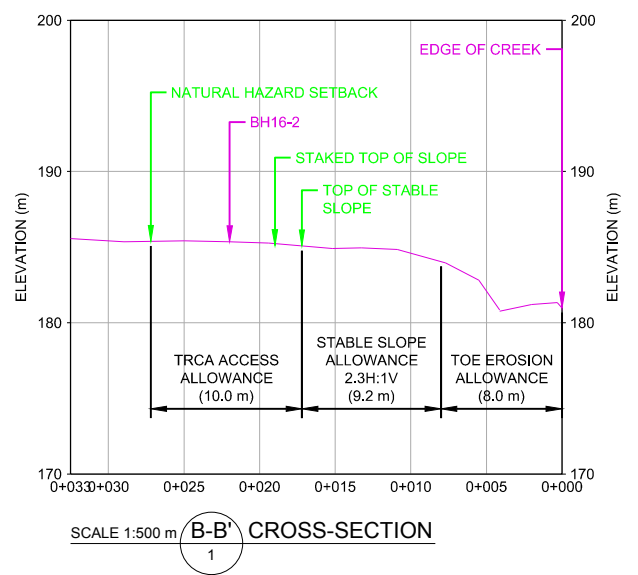
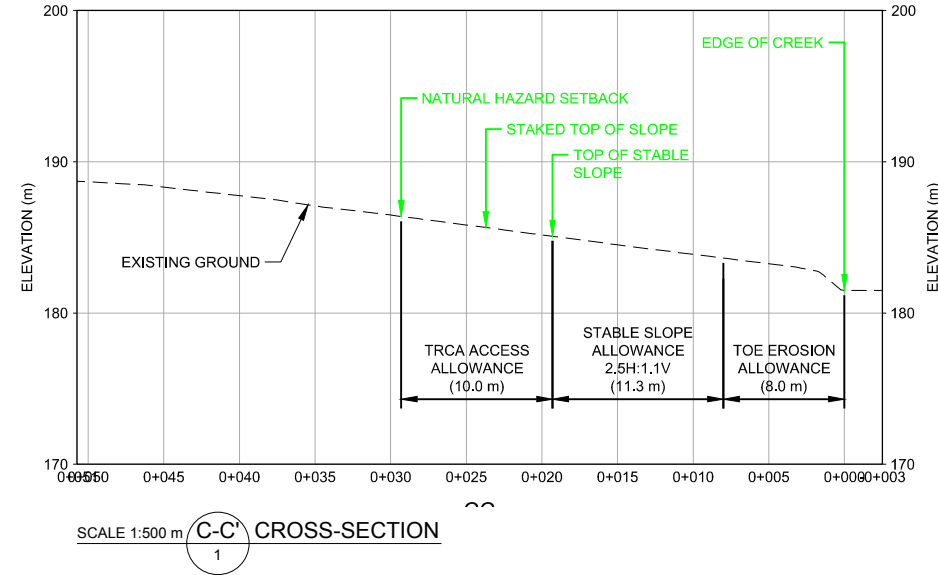
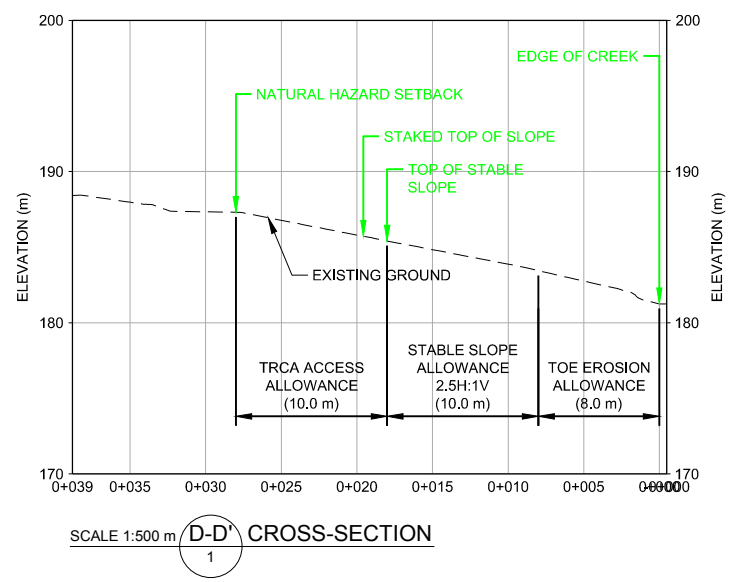
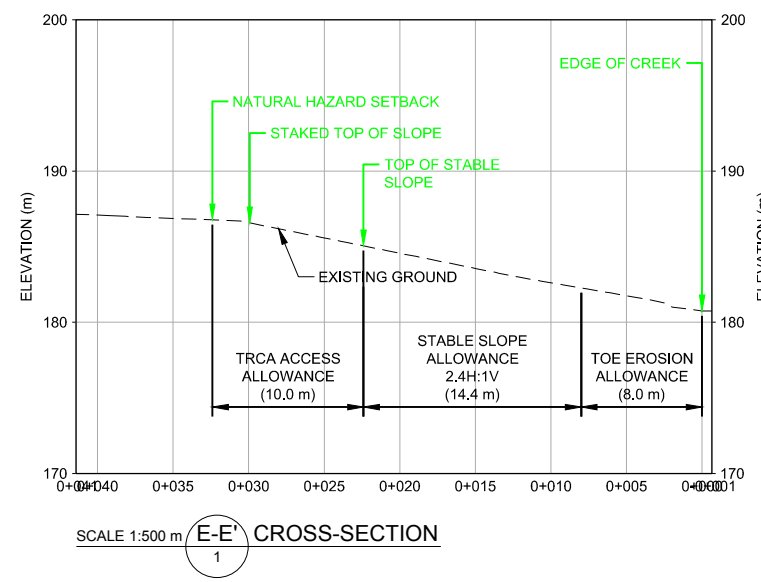
Based on the data derived from the detailed analysis carried out at the slopes adjacent to the borehole locations, Golder has also assessed additional slope sections at the 3 other sections shown on Figure 1. The detailed sections and setbacks are shown on Figure 2. The following table summarizes the individual setback requirements, and the total setback from the edge of the creek (creek bank) at all five of the sections.
